## CORRECTIVE ACTION STABILIZATION QUESTIONNAIRE

Facility Name: Ball CorporationEPA Identification No.: IND 000 810 713Location (City, State): Muncie, IndianaFacility Priority Rank: ModerateRECEIVED  
WASTE RECORD CENTER

# **TES 9**

Resource Applications, Inc. (RAI) performed a preliminary assessment and visual site inspection (PA/VSI) to identify and assess the existence and likelihood of releases from solid waste management units (SWMU) and other areas of concern (AOC) at the Ball Corp. (Ball) facility in Muncie, Indiana. This summary highlights the results of the PA/VSI and the potential for releases of hazardous wastes or hazardous constituents from SWMUs and AOCs identified. In addition, a completed U.S. Environmental Protection Agency (EPA) Preliminary Assessment Form (EPA Form 2070-12) is included in Attachment A to assist in prioritization of RCRA facilities for corrective action.

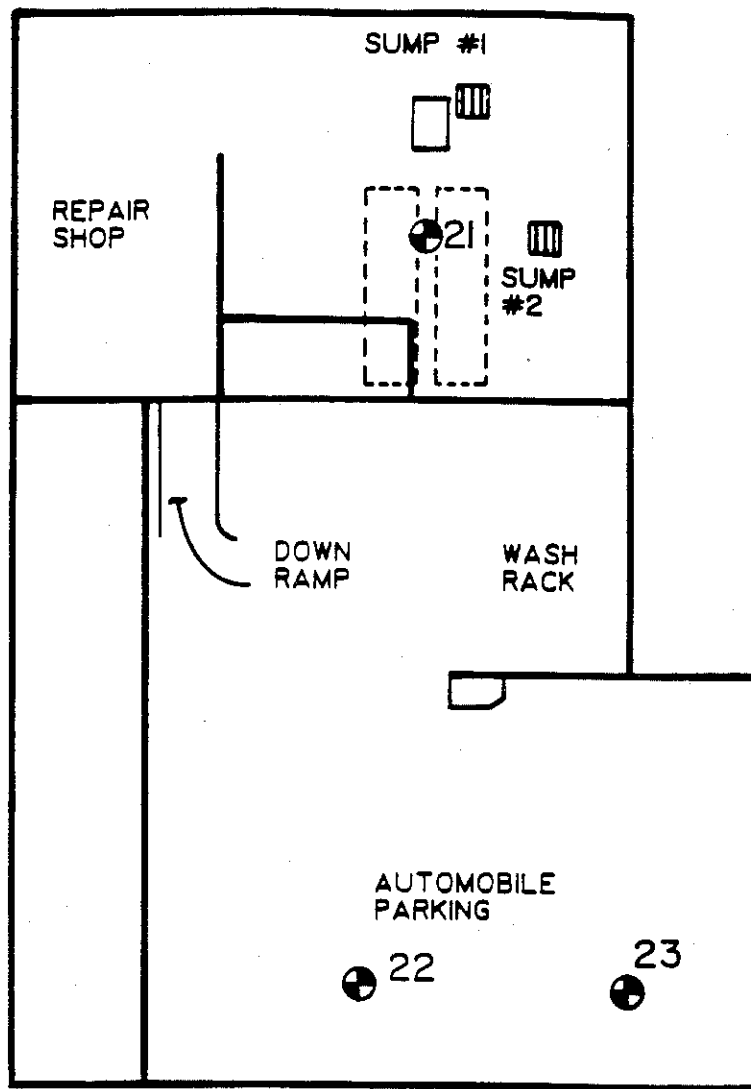
BORING PLAN - PHASE III  
LEAKING UNDERGROUND STORAGE TANK  
BALL CORPORATION  
MUNCIE, IN

Three observation wells were installed during Phase III as shown in Figure 4. The wells consist of 10 ft of 2 in. I.D. Schedule 40 PVC with 5 ft of 0.10 factory slotted screen. One well (B-21) was installed directly between the two underground tanks to monitor the amount of product present at this location. Borings B-22 and B-23 were installed in the parking

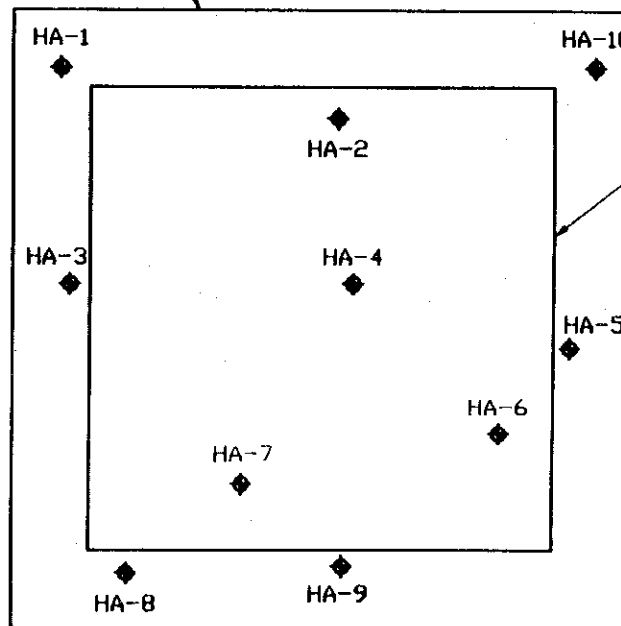
LOCATION OF  
FORMER PAD  
BUILDING #56

PERIMETER OF MAXIMUM  
CONTAMINATION (5' BEYOND  
BUILDING PAD)

Ball requests that the status of the former Building 56 hazardous waste storage facility be changed to closed.

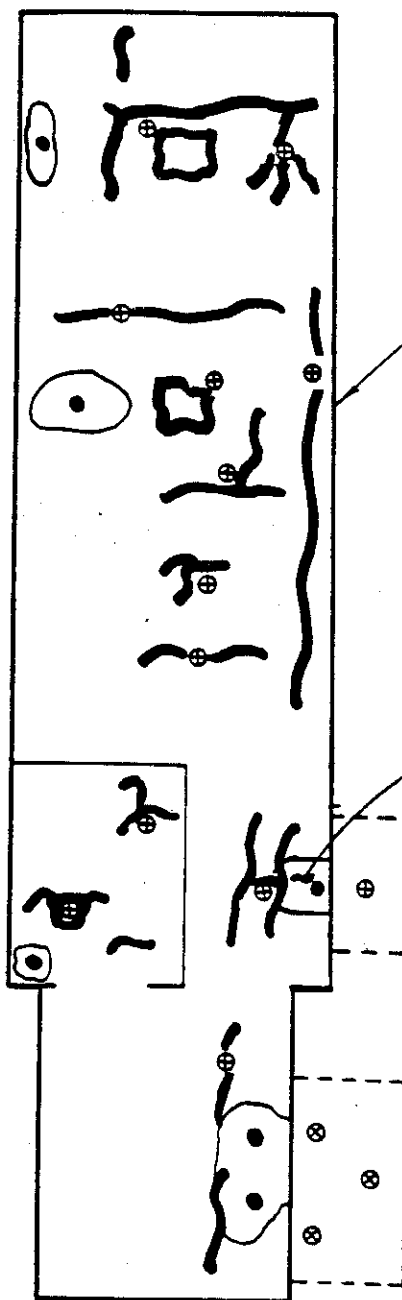
BUILDING 48  
CONCRETE PAD

The positive results for cadmium and the specific SVOCs, in our opinion, are not a result of any operation that was conducted within the Building when it was a waste storage facility, and are not sufficiently high to warrant any remediation. The industrial site on which Building 48 is located has been used for heavy industrial manufacturing for 103 years. A certain amount of low level oil and metal deposition into the soil would be expected to have occurred over this time period. The levels are low, and do not show any pattern that would indicate contamination from a spill or leak.

SURFACE STAINED PAD
